**Conference on Land Policy in Africa
(CLPA-2019)**

Title: INFORMALITY IN URBAN AREAS, A CASE OF LAND USE TRANSFORMATION IN MLALAKUWA SETTLEMENT, DAR ES SALAAM.

Event Category: Conference Paper

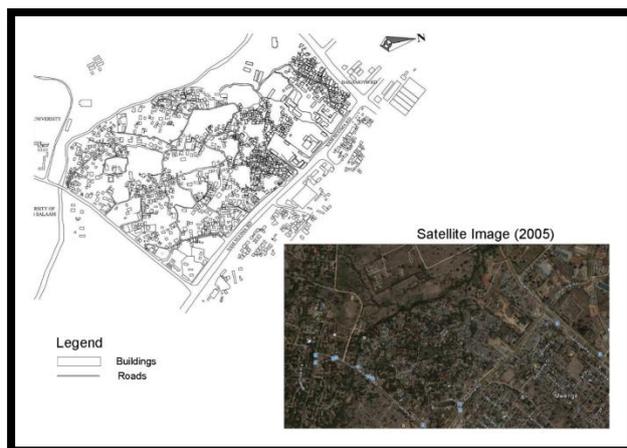
Figure 4.1: Existing land use of the study area in 2005

The image of 2005 shows large part of the study area was undeveloped and other areas were partially developed as seen in figure 4.1. Analysis shows the densely built area was covering 88 acres and sparsely built was covering 62. The unbuilt areas were covered by trees and other parts were used for gardening activities. Most buildings were low rise and few high rise. This was before the expansion of Sam Nujoma road, the opening of Mlimani city shopping mall and other nearby institutions as seen in figure 4.15

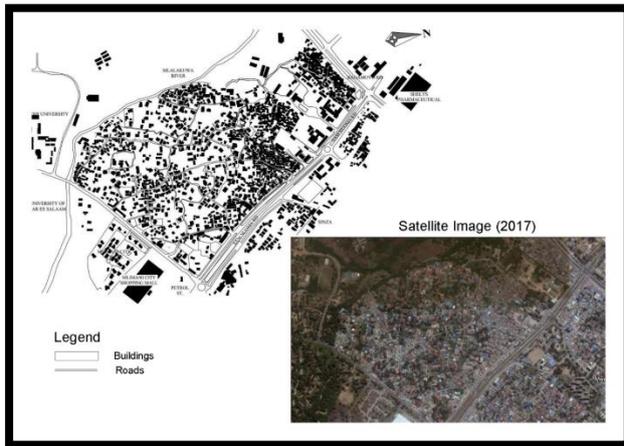
Figure 4.2: Land use in the study area 2017

According to the satellite image and field observation, there is a clear expansion of densely built area as a result of increased buildings as seen in figure 4.2. The undeveloped land has been significantly reduced as the years passed by to 2017. The analysis on the land use transformation in the study area was done basing on the area where the transformation process was observed. The 2017 image shows densely built area was covering 121 acres and sparsely built area 32 acres.

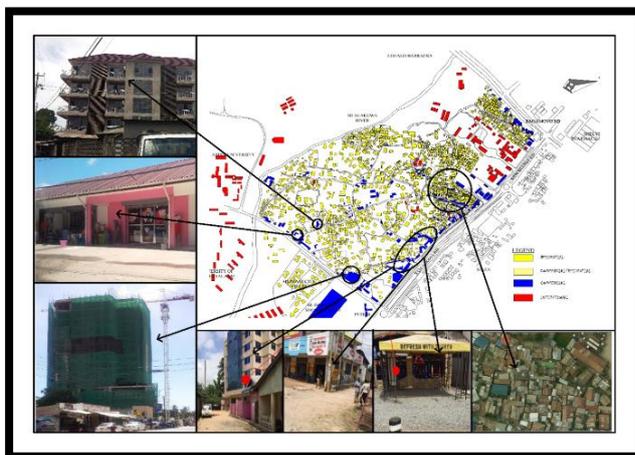
Figure 4.3: Some areas selected for detailed study

Based on field observations and analysis of the satellite image, areas that were observed to have exhibited land use transformation were established as shown in figure 4.3. The different types of transformation were observed on built and unbuilt spaces. In each subcase, the analysis was done to establish what was there in 2005 and compare the same with the image of 2017.

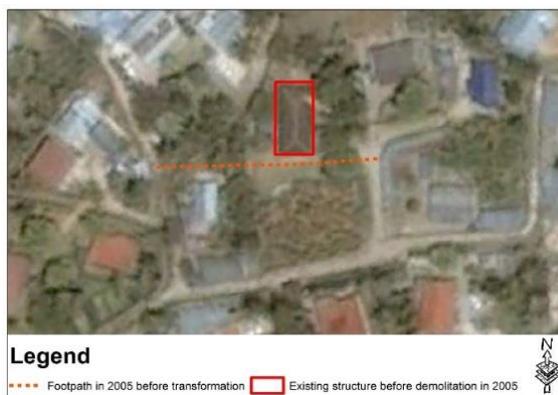
Figure 4.4: Existing building before demolition and replacement

In 2005, the space was occupied by one building. According to developer the space around was used as footpath and children playground.

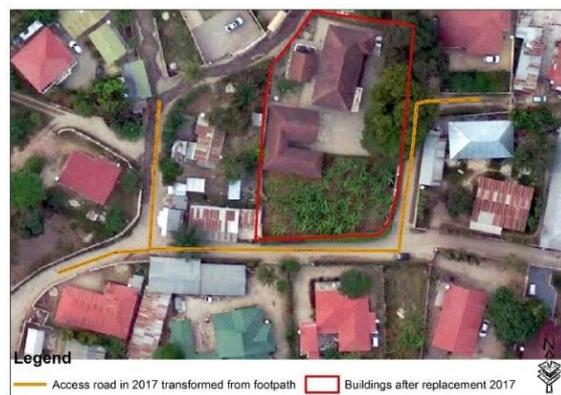
Figure 4.5: Existing building after transformation and replacement, 2017

In 2017, the building had been demolished and new buildings built. The footpath had disappeared while part of the space was used for gardening. One of the building one was used by the owner and the other was rented out for residential purpose.

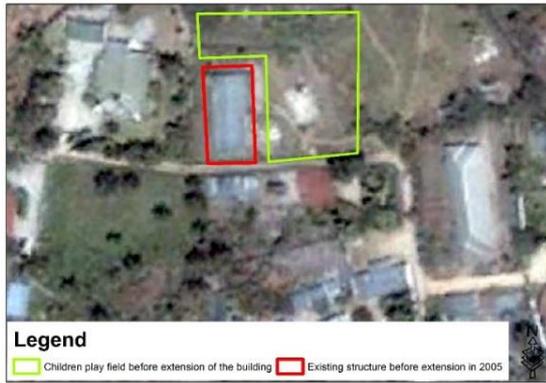
Figure 4.6: Existing building before extension of the Property, 2005

As shown in the image of 2005, the plot had only one building that covered 25% of the total plot area. According to developer the rest of the area was used as footpaths, children playfield and animal keeping. Also the open space had trees which protected the environment and provided shade and greenery to beautify the environment.

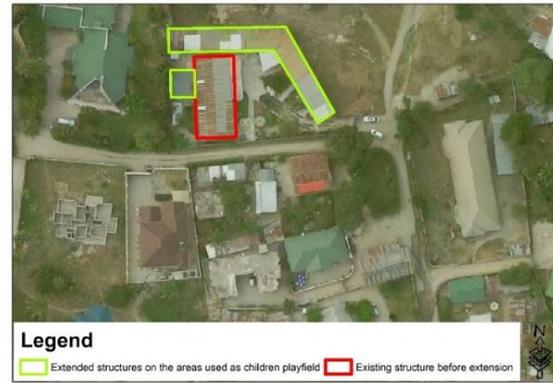
Figure 4.7: Existing building after extension, 2017

In 2017, the open space was occupied by the extended building which had blocked the footpaths, reduce children play area and garden. The extended building was used for rental purposes to students and other residents working in the nearby areas.

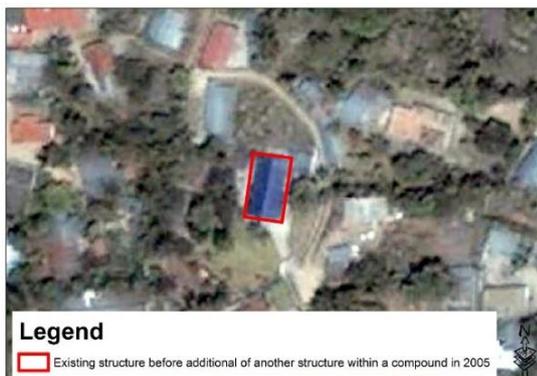
Figure 4.8: Existing building before addition of other units in a compound, 2005

In 2005, the plot had only one building and the rest of the area was covered by trees and other vegetation. The space around the building was used as footpaths, children playing grounds and trees that shaded the environment.

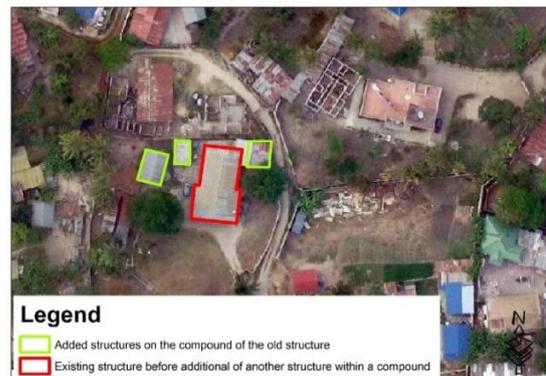
Figure 4.9: Existing building after addition other units within a compound, 2017

In 2017, several small buildings had been erected as seen in the image. New structures in front and back of the buildings were constructed for rental purposes.

This type of land use transformation occurred when new independent building was erected besides existing buildings, not attached but within the same plot as shown in figure 4.9. Property owners had a tendency of adding. Addition of new rooms was always done in the front side of the main building if it was for commercial use and in the backyard of the main building if it was for rental purpose or serving added family members.

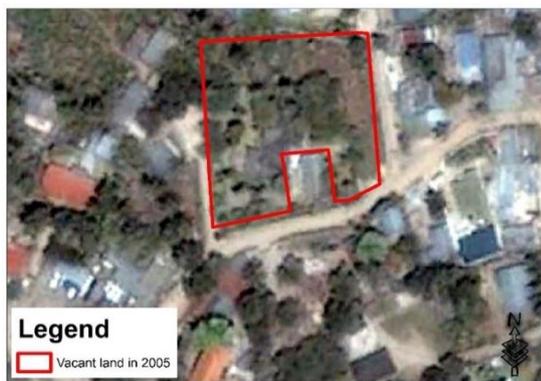
Figure 4.10: Open/vacant land before additional of building structure, 2005

In 2005, the land in the study area was covered by vegetation and used for farming activities.

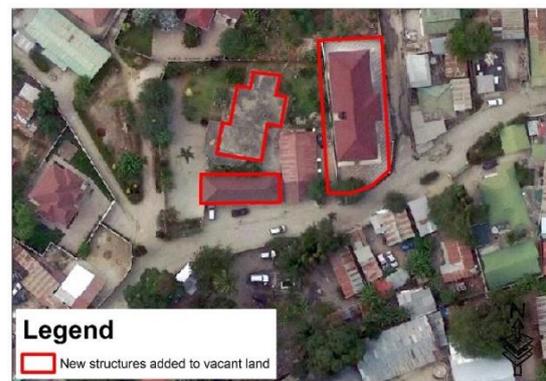
Figure 4.11: Existing building added to vacant land, 2017

In 2017, the area had been transformed into buildings which are used for commercial and residential activities as seen in figure 4.11.

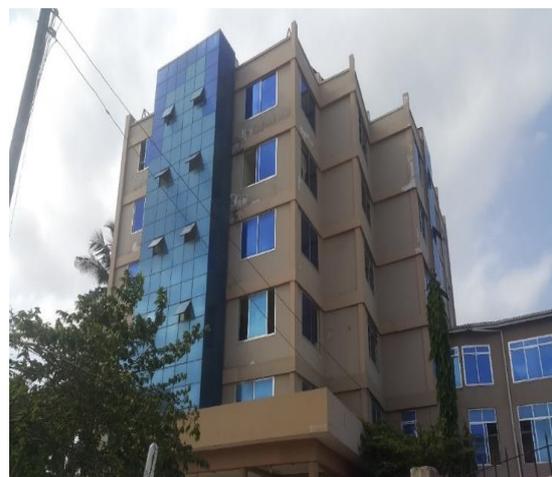
Figure 4.12: One of the multistory buildings used as Students' hostel at the study area

Land use transformation in the study area had also changed vertically overtime. Before 2005, According to Mtaa leader, the area had 98 percent of the buildings which were single-story and 2 used for residential purposes. In 2017, 9 percent of the buildings had changed from single story to multi story buildings. These multi-story buildings were used for residential and renting for commercial purposes. Vertical land use transformation in the study area involved total demolition of the previously existing buildings and replaced with a new building. The plot coverage is always the same as the previous building but plot ratio increased due to increase in number of floors.

The transformation process had resulted in income generation to the property owners who transformed their structures for renting and other commercial purposes. Figure 4.12, shows the new students' hostel for income generation.

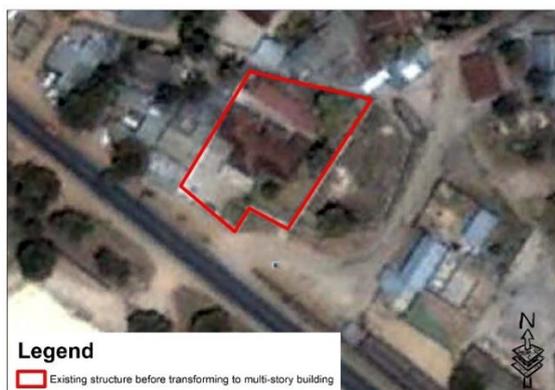
Figure 4.13: Existed building in 2005 before transformation

In 2005 the area had single story building which was used as a residential house. The building was covered 50% percent of the total plot area and the other area was used as open space and garden.

It involved both, extension of the spaces horizontally and vertically. The new building acquired more space horizontally and also increased vertically. The horizontal expansion of different uses acquired more spaces hence affected other land uses. 90 percent of building structures with more than two stories in the study area fall under this category as observed in the field and analysed from the satellite images as shown in figure 4.13 and 4.14.

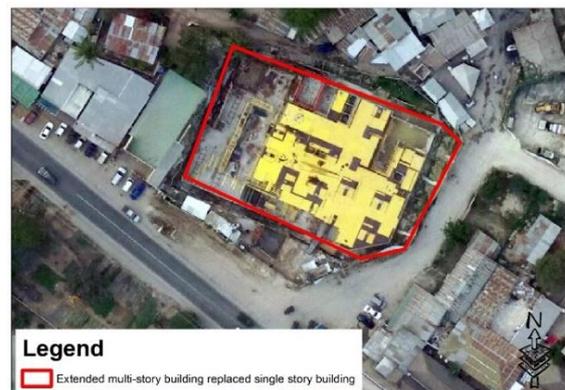
During the study in 2017, the area was still under construction to multistory building which replaced the old one. The new building is covering larger space vertically and horizontally than the previous one. Since buildings are congested, construction activities affected neighbors in many ways from dust, noise and falling objects.

Figure 4.14: Multi-story building which is extended vertically and horizontally, 2017

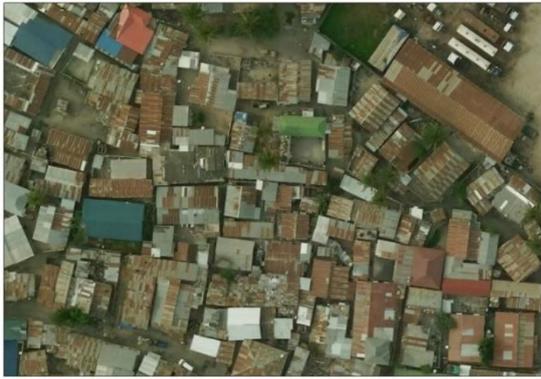
Figure 4.22: Buildings crowding reduce vehicular mobility, privacy and impose settlement in danger in case of fire outbreak

Unguided land use transformation has led to excessive densification that is evidenced by the dramatic increase in built up area and buildings' crowding (see figure 4.22). Other negative effects of unguided land use transformation include occupational reduced privacy in residential areas, land use conflicts and reduced accessibility since public spaces such as access roads are either being restricted (see figure 4.23) and some are relocated to other places

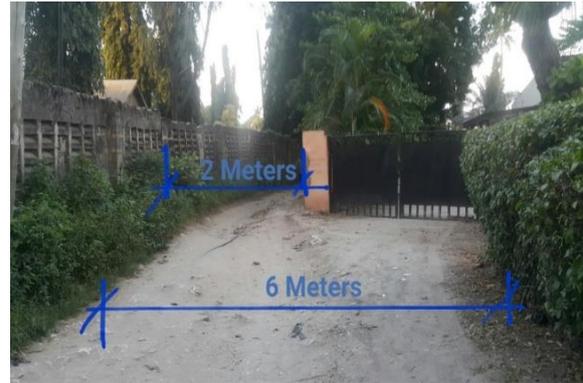
Figure 4.23: Extended fence wall that narrowed access.
